Technical Bulletin

Potential lockout condition with revision "B" controls

Date: March 10, 2009

Tech Bulletin #: TB09.002

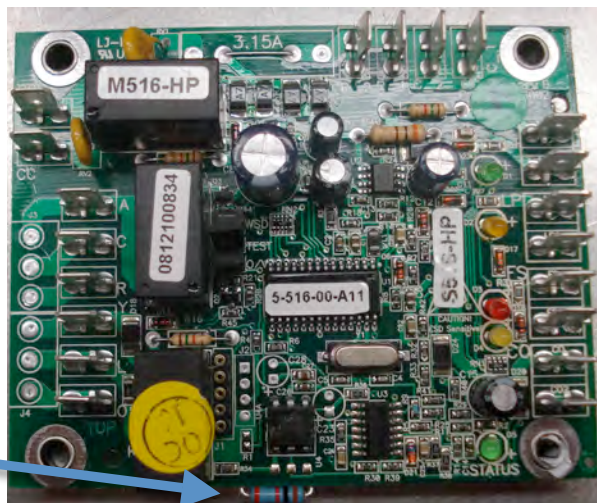
The cause of this behavior is back feed voltage from the ECM fan motor. In some cases, depending upon the line voltage and the quality of power, the back feed voltage may be enough to energize the lockout board, thereby engaging the compressor relay that sends 24VAC to the compressor contactor coil. We have not been able to duplicate the condition in our Greenville location. Therefore, we do not expect this condition to occur on any widespread basis. Our board vendor has made a change to the lockout board to avoid any future potential issues.

1k Ohm resistor
(1/2 Watt) added
at the plant to
eliminate back
feed voltage

The plant in Mitchell has made the change to all units currently shipping. The warehouse in Greenville is adding the change to all units in stock. All units shipping now include the modification. Below is a picture of the new lockout board.

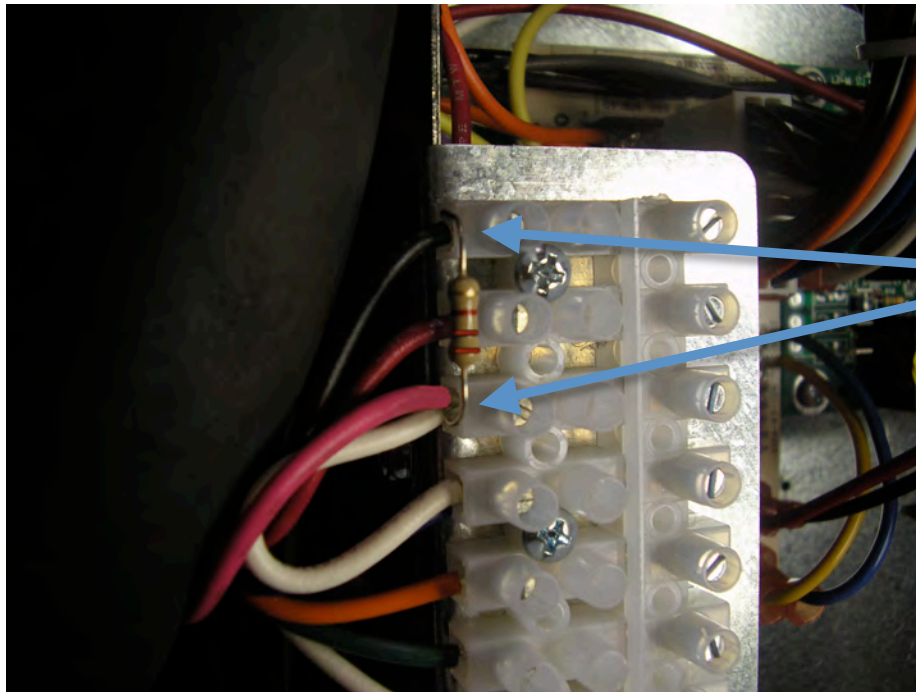
For units already installed that exhibit this condition, the picture below shows an alternate method that achieves the same results. Units shipping from the Greenville warehouse will have the alternate design as shown below; units shipping from Mitchell have the new lockout board, as shown above. Eventually, all units will be shipping with the new lockout board, and will not have a resistor at the terminal strip.

Attach 2.2k Ohm resistor (1/2 Watt) between Y1 and C at the left hand side of the low voltage terminal strip.

It should be noted that if the compressor contactor has failed, the technician should look for a resistor either soldered to the board or attached to the terminal strip. If no resistor is present, the resistor should be added when the contactor is replaced.
