# Technical Bulletin

Potential Desuperheater Water Leak

Tech Bulletin #: TB10.004

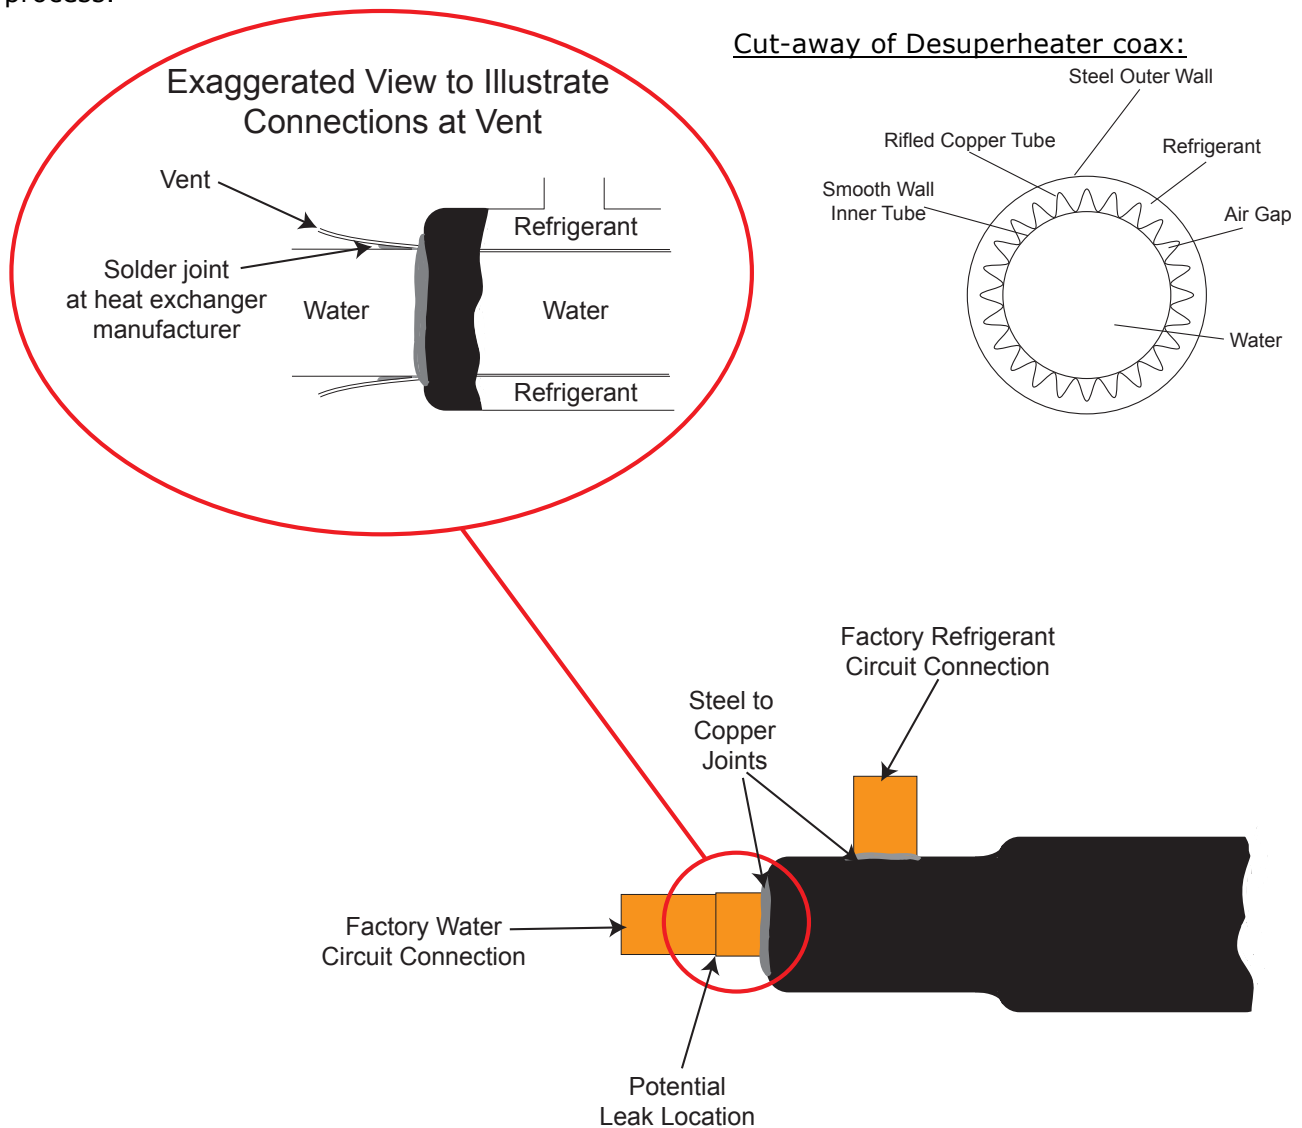
In a few cases, as we brazed the joint on the water side of the Desuperheater, the technician may have overheated the coax manufacturer's braze joint. The potential leak location is shown below. If there is a leak, it can be re-soldered with a solder similar to StayBrite 8 and a general purpose flux at the point noted as "solder joint" on the exaggerated view illustration below (also shown in the view at the bottom of the page as "potential leak location"). This will not change the integrity of the vent on the double wall coax.

Any unit serial number before M10060414 is suspect for a potential leak; units manufactured after this serial number include a change in process, which will avoid future leaks due to the factory braze joint. This repair will be covered under the normal warranty process.

**The Desuperheater coax does not need to be replaced.**
