Technical Bulletin: 1/4" Copper Tube Failures

Rev.: 26 Feb 2016
P/N: TB16.003

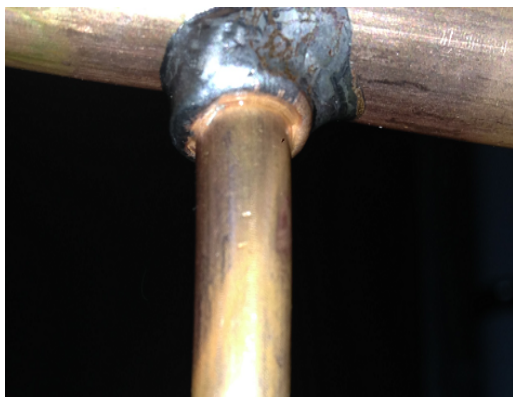
On February 10, 2015, Enertech released a bulletin highlighting the discovery of a quality issue regarding breaking 1/4" copper tubes. During the investigation into this issue, it became apparent that there is an additional quality issue regarding the amount of fill material used on braze joints. In some cases, brazing operators failed to apply enough fill material to ensure a solid joint. This has mostly been reported on 1/4" lines containing the bead stop. See picture below.

Upon discovery of this issue, the following actions have been taken:

1. The details of this issue have been widely communicated with plant personnel.
2. Additional training has been completed by brazing operators.
3. Additional quality checks throughout the manufacturing process have been added to ensure braze joints are of acceptable quality.
4. Employees have been and will continue to inspect and where necessary repair stock units.

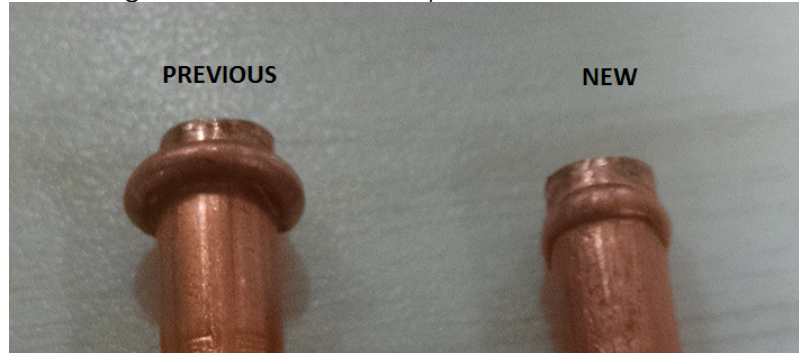
1. It was initially communicated that the eight units in question were all produced within the serial date range of M1406*** & M1501***. It should be noted that this was merely an observation taken from those initial eight units. We are now aware that this condition has been found outside of this date range.
2. The plant is continuing to 100% sort all 1/4" copper production parts for defects.
3. The radius edges of the bead stop have been lessened to reduce the likelihood of forming induced stresses. See picture below

4. New tooling has been ordered for the bead stop machinery.

Customers that experience either of these issues should file a warranty claim and if necessary, request Enertech P/N 28K043-01NN (Universal 1/4" Copper Tube Repair Kit). The standard labor reimbursement rate for refrigerant system leaks will apply. As always, any specific application or installation related questions should be directed to Enertech Tech Support at 618-664-5860.
