Technical Notice: 3.2A Transformer Breaker

Rev.: 05 December 2014
P/N: TB14.001

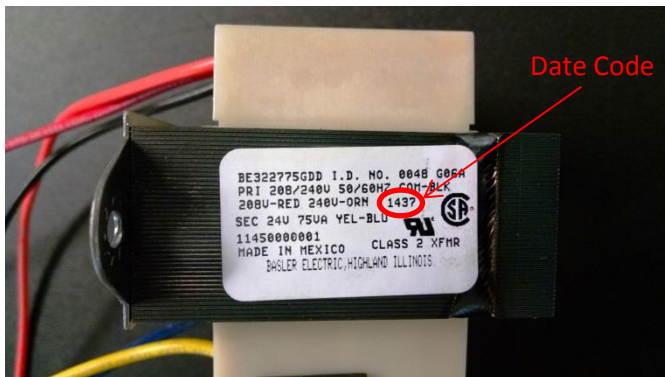
Figure 1.

Only WS036-084, WD120, and WT036-144 water-to-water units do not have an external fuse protected circuit. The affected date range was September 1 to November 30 of 2014 (S/N: M1409**** to M1411****). Also, a date range can be viewed on the transformer label (see Figure 1). Transformers with date codes between 1435 and 1446 are known to be affected by the breaker issue. The transformer breaker quality was addressed with the vendor and a breaker change has been made on all future transformers.

This is an elective, non-mandatory modification. For further prevention of a transformer failure, EnerTech is offering a replacement transformer and labor for the change out of the transformer. A warranty claim form must be filed and the unit and transformer must meet the criteria listed above. Units after November 30, 2014 (S/N: M1412****) are being manufactured with new transformers with sufficient breakers. The part number for the replacement transformer is 1145000001.
