<p>ENERTECH Geothermal Made Better™ 2506 South Elm Street Greenville, IL 62246 www.enertechgeo.com info@enertechgeo.com</p>	<h2>Technical Notice</h2>
	<p>TN15.001 Refrigerant Tube Leak – ¼” Tubing</p> <p>REV.: 11 February 2015 P/N: TN15.001</p>

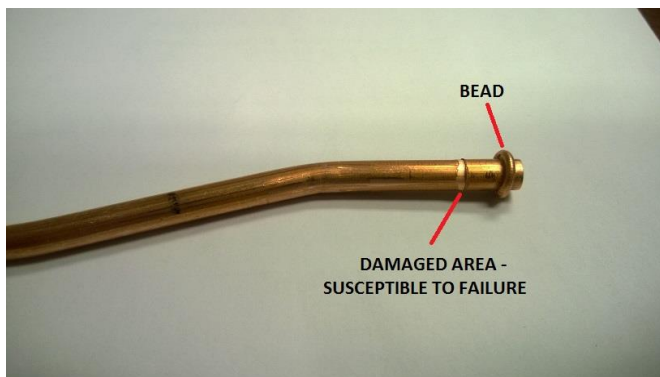
Enertech Global, LLC has become aware of at least 8 *XT/CT units that have experienced low hour failures because of a leak that develops on ¼” copper tubes. The unit serial numbers for the failed units all fell between M1406*** & M1501***. Most often, this leak is found where the tube from the high pressure service port connects to the discharge line but it has also been discovered on ¼” lines located elsewhere within these units.

Through investigation at the manufacturing plant, it has been discovered that a small percentage (1- 2%) of ¼” tubes are being damaged during the copper straightening and forming processes (see picture below). This damage weakens the wall of the tube making the tube susceptible to failure during transit to the customer location and/or during routine cycling of the unit.

All ¼” tube stock has been sorted and verified as good. The operations group has worked diligently to identify the true root cause and implementations of permanent corrective action(s) are pending. In the interim, all production completed on the suspect piece of equipment is being 100% inspected prior to placement into inventory.

Customers experiencing this issue should file a warranty claim and request Enertech P/N 28K043-01NN (Universal ¼” Copper Tube Repair Kit). The standard labor reimbursement for a refrigerant system leak will apply. As always, any specific application or installation related questions should be directed to Enertech Tech Support at 618-664-5860.
