ENERTECH
Manufacturing, LLC

Technical Bulletin

Honeywell Product Issue: 3-Pole Contactor

Bulletin #: TB08.006

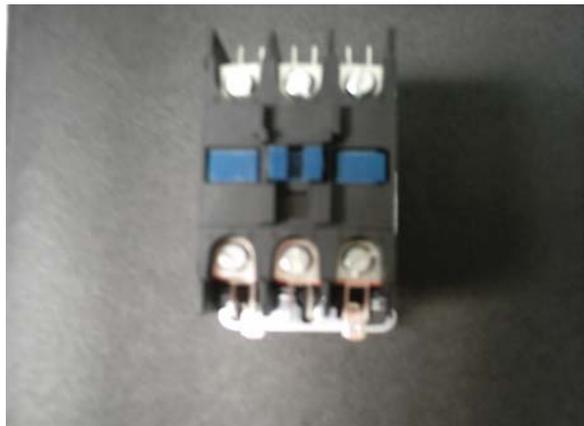
Figure 1

After researching our warranty history, we have flagged a quality issue with the Honeywell DP series 3-Pole Contactors. These contactors were used in our units from February 2006 to March 2008. Further review allowed us to determine the reason for failure. We are confident the normal operation of the units is not causing the failure, but the design and functionality of the contactor is causing failure. There is plastic, which can come into direct contact with one of the internal, metal contacts. Immediately following a run cycle, the contact will be at a higher temperature. This higher temperature allows the metal to fuse itself to the plastic.

Once the metal contact fuses to the plastic, the next cycle will not be fully initiated because the full voltage is impeded by the immobilized contact. The contact can cool off and begin to work properly after a short period of time. In some cases, the contact will be immobilized long enough to cause a hard lockout on the unit. The control board will show a FLOW lockout due to improper voltage supplied to the flow center pumps. After a lockout, the unit has usually remained off long enough for the contact to cool and release from the plastic. This means the unit may run a perfect cycle when the technician services the unit.

- 1) First identify that the contactor is a Honeywell brand (see Fig. 1).
- 2) Once it is determined the unit has the faulty contactor, remove it and order a replacement under warranty.
- 3) Units repaired out of the warranty period will be credited for the replacement contactor. For those units out of warranty, reference the contactor's full description and/or this tech bulletin during the ordering process to initiate the proper paperwork for the contactor part credit.
